BARRICK MERCUR GOLD MINE

Subject: Dump Leach Area 2

BARNICK MERCUR GOLD MINE
DUMP LEACH 2
 PRODUCTION CISTERN
 LAYOUT
 SCALE: 1" = 50'
 BY ARS
 Dwg. 89-5-1
 27 JUL 89
 SHEET 1 OF 2

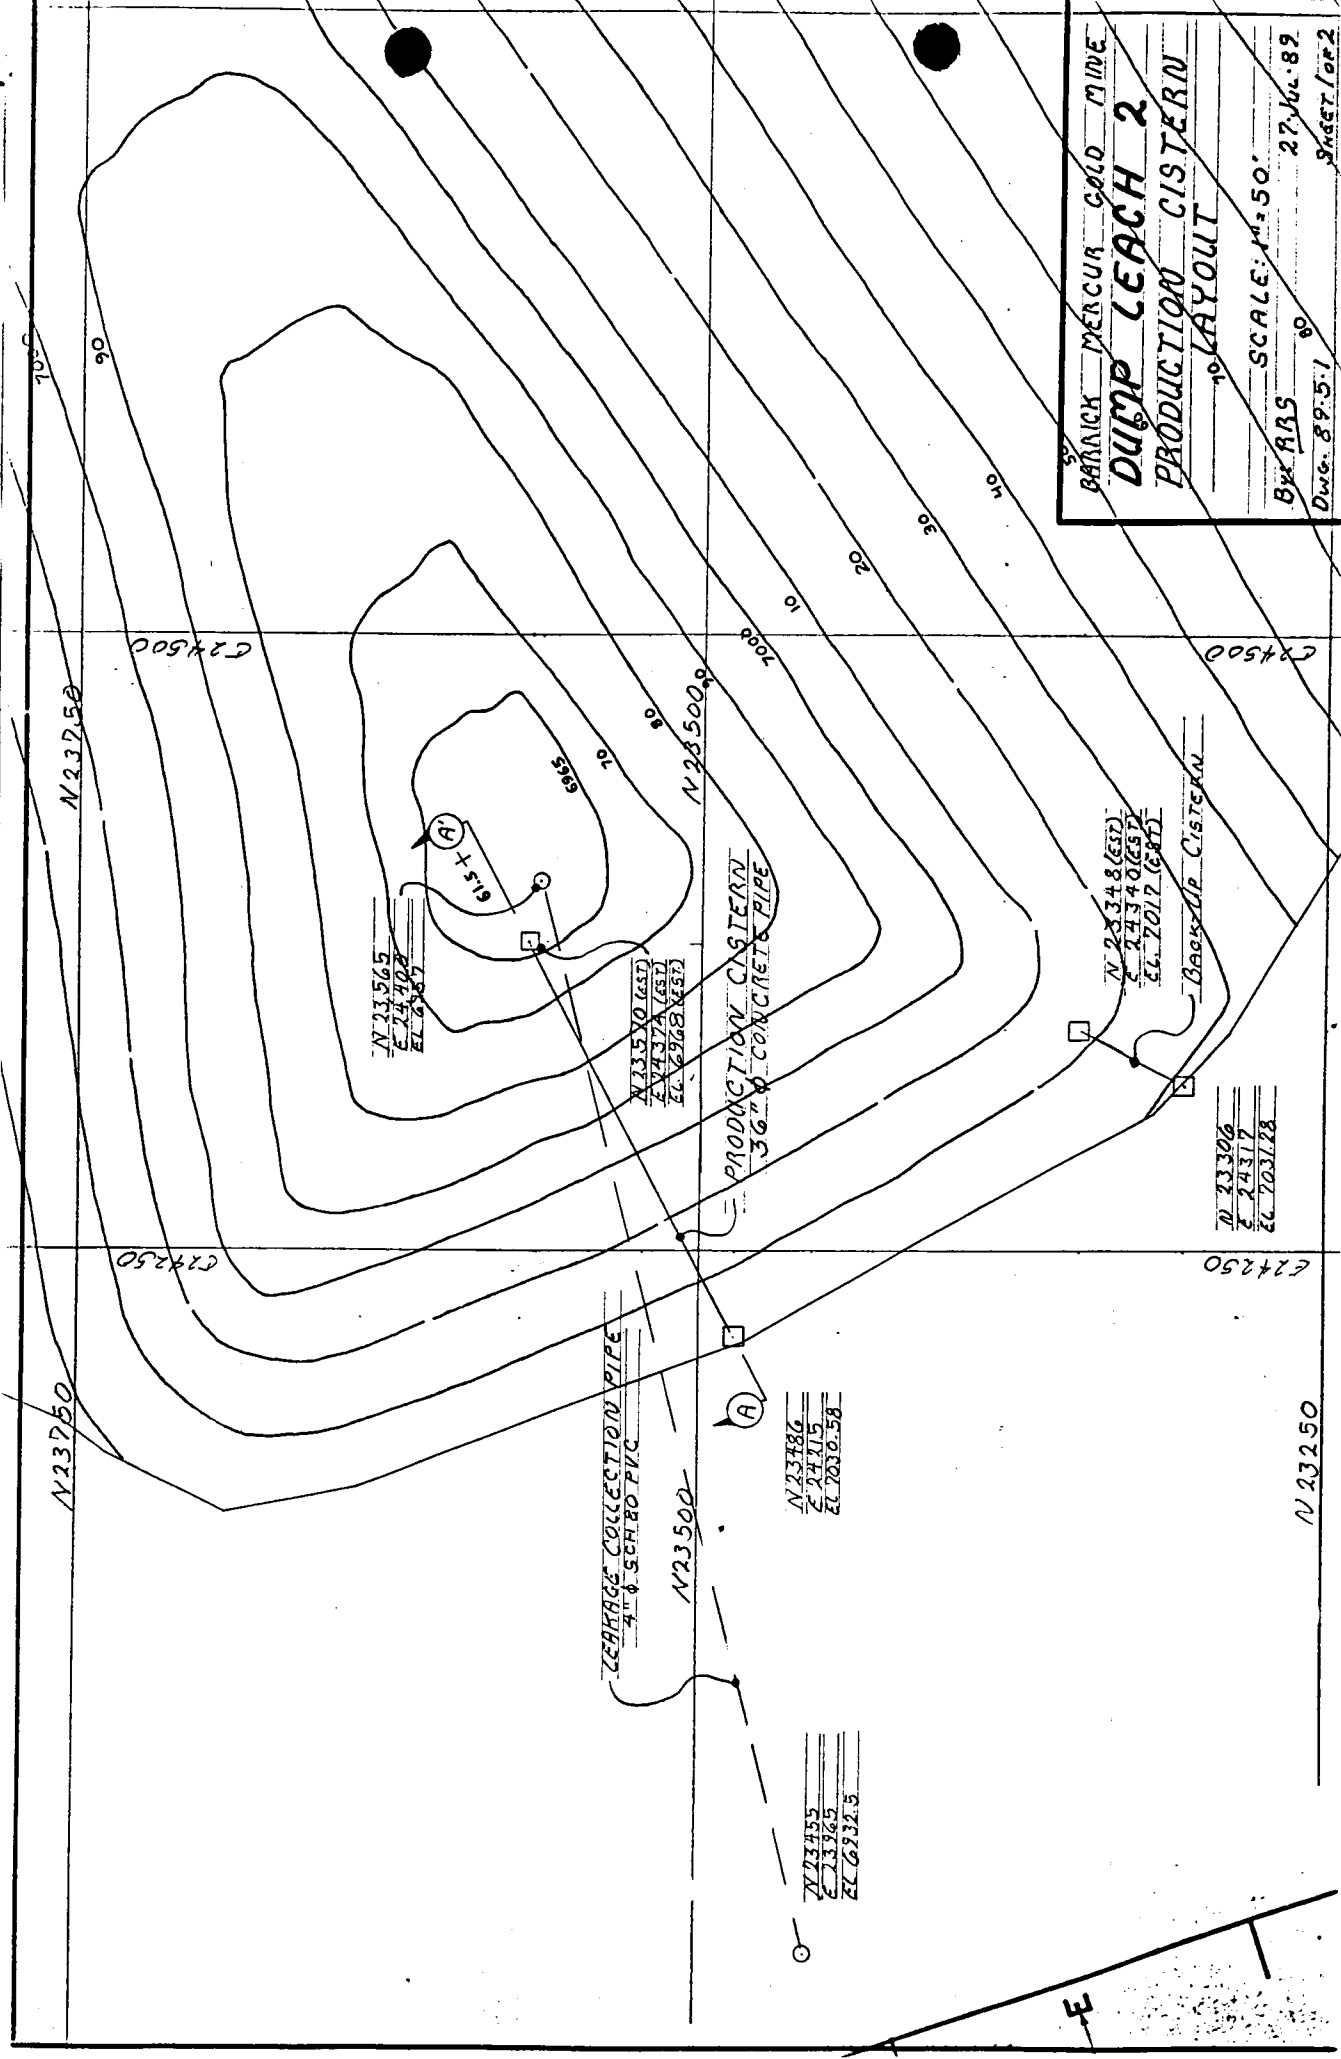
LEACHAGE COLLECTION PIPE
4" SCH 80 PVC

PRODUCTION CISTERN
36" CONCRETE PIPE

Back-Up Cistern

- In mid-July 1989 the pregnant solution pump was reset to the lowest point in the cistern. This will result in an additional decrease in solution depth under normal operating conditions. The arrangement of the cistern and all relationships are shown in Exhibit 1.
